Sample Section of a Heritage Survey

Somerset House

E5 Windows

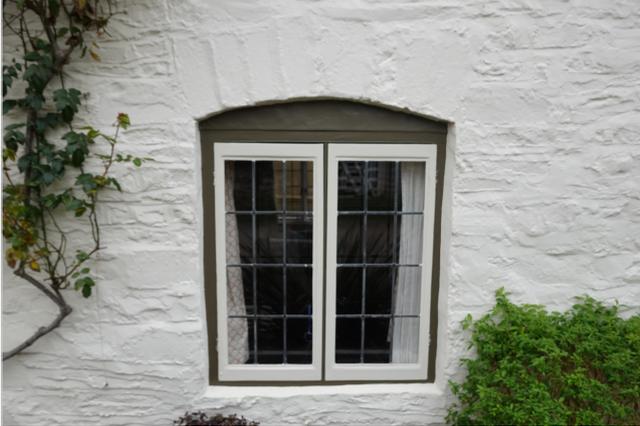
Limitations to inspection	The inspection was carried out from ground level using binoculars.
E5 Windows	
<p>Most of the windows within the property consist of timber framed casement windows with single-glazed leaded lights. There has been an effort to secondary glaze these windows throughout. This has been carried out by use of either openable secondary glazed shuttering, or permanent, unopenable glazing. A sample selection of secondary glazing was inspected closely and found to be polymers (plastics) and are assumed to consist of acrylic, perspex or similar. The secondary glazing is visually unobtrusive.</p> <p>Timber-framed casement windows with double-glazed units have been provided elsewhere, including to the dining room extension, the first floor windows of the east gable, the windows to the garden room, and the slit windows to the downstairs WC. Where these have been provided, they are decoratively similar and are in keeping with the property.</p> <p>The property has been provided with two Velux windows located within the garden room roof and the bathroom roof. These are both double glazed.</p> <p>Generally, the windows are in good order. Those that were tested are operable. The decorative finish is in good condition in all cases.</p> <p>The window frame to the left-hand dormer window has been strengthened at the corner joints. This may be the result of previous moisture ingress to the joint causing deterioration of the tenons or the glue fixing (where it may exist). The decorative finish is to a high standard, which will protect the timber from future moisture-related damage. It is unclear as to the condition of the joints, although consideration should be given to instructing a joiner to overhaul the window generally.</p> <p>No evidence of FENSA certification for the replacement windows was identified during online searches, and no documentation was made available at the time of inspection. FENSA certification confirms that replacement glazing installations comply with the relevant Building Regulations. It is recommended that the legal advisor makes further enquiries to establish the date of installation and to confirm whether any certification or Building Control approval exists.</p> <p>Condition rating 2: These issues are not considered to be serious or urgent but should be carried out soon.</p>

Ground floor window representative of the condition throughout.

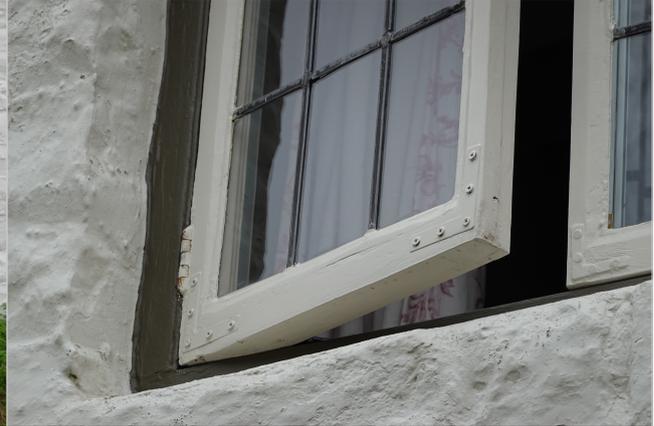
Reinforcement of window joints is evident sporadically.

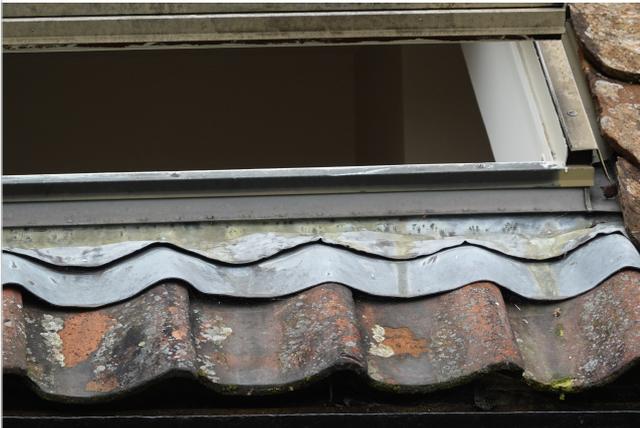
Warping of lead details will ultimately lead to cracking, requiring replacement.
