E2

Roof Covering Outside the property

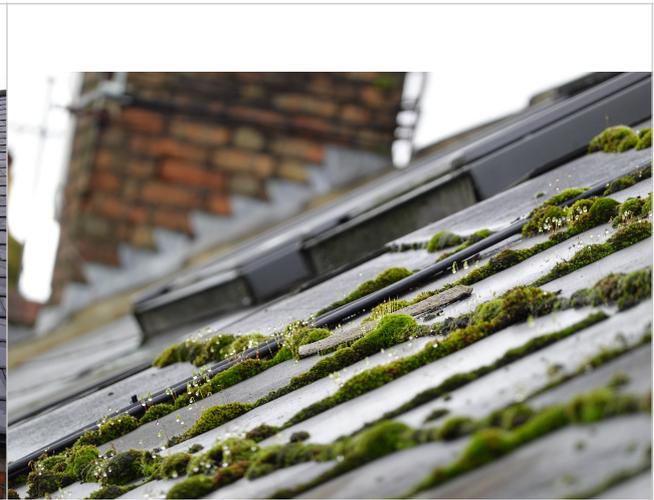
Moss accumulation

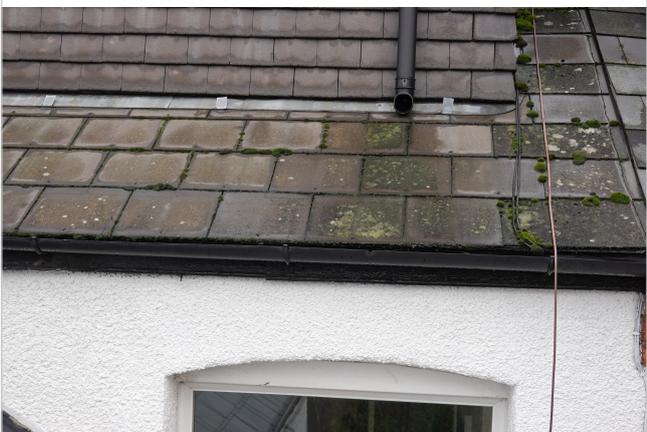
Rear roof pitch

The property has a rear projection that is similarly covered with slate tiles. The ridge is formed with mortar-bedded angled ridge tiles. The mortar beds for these tiles are larger than necessary, resulting in excessive exposure of the mortar. Some of the joints are beginning to weather. Repointing of this element should be considered in the next few years. The verge detail for this element (where the roof covering meets the wall on the south gable side) is fully mortared as part of the rendering.
